Echo Lake Dam

Field File No. 51.01

Key Sequence No. 602

Re: Post Flood
Dam Safety Inspection Report

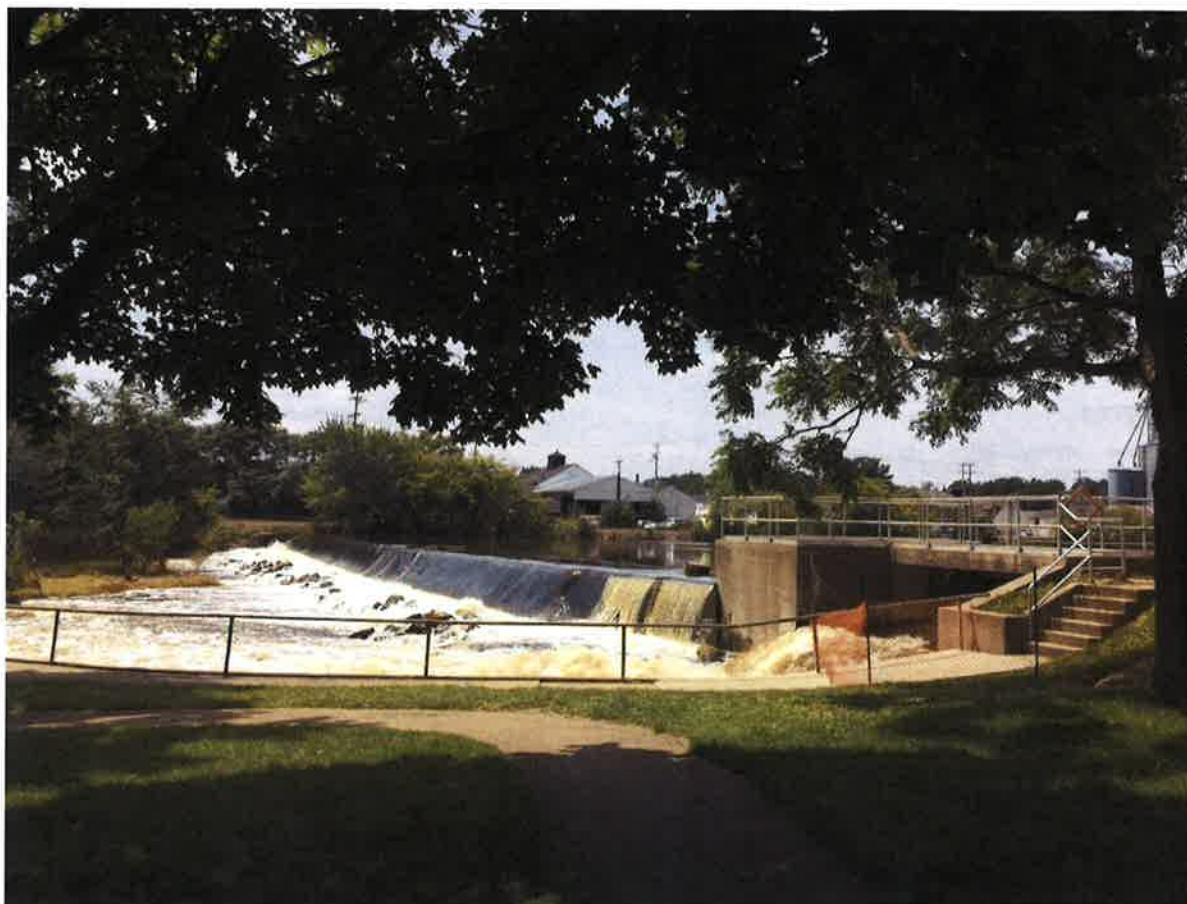
Burlington Echo Lake Dam
Photo During Flood (Taken July 25)

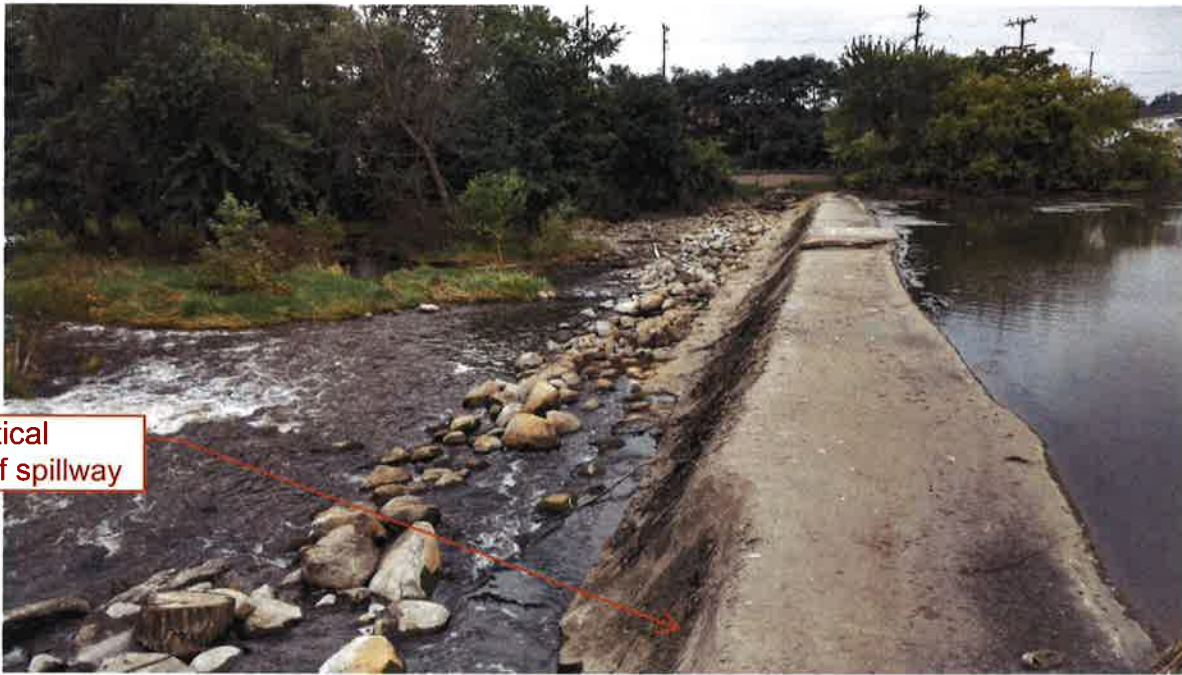
Burlington Echo Lake Dam
Auxiliary spillway viewed from left

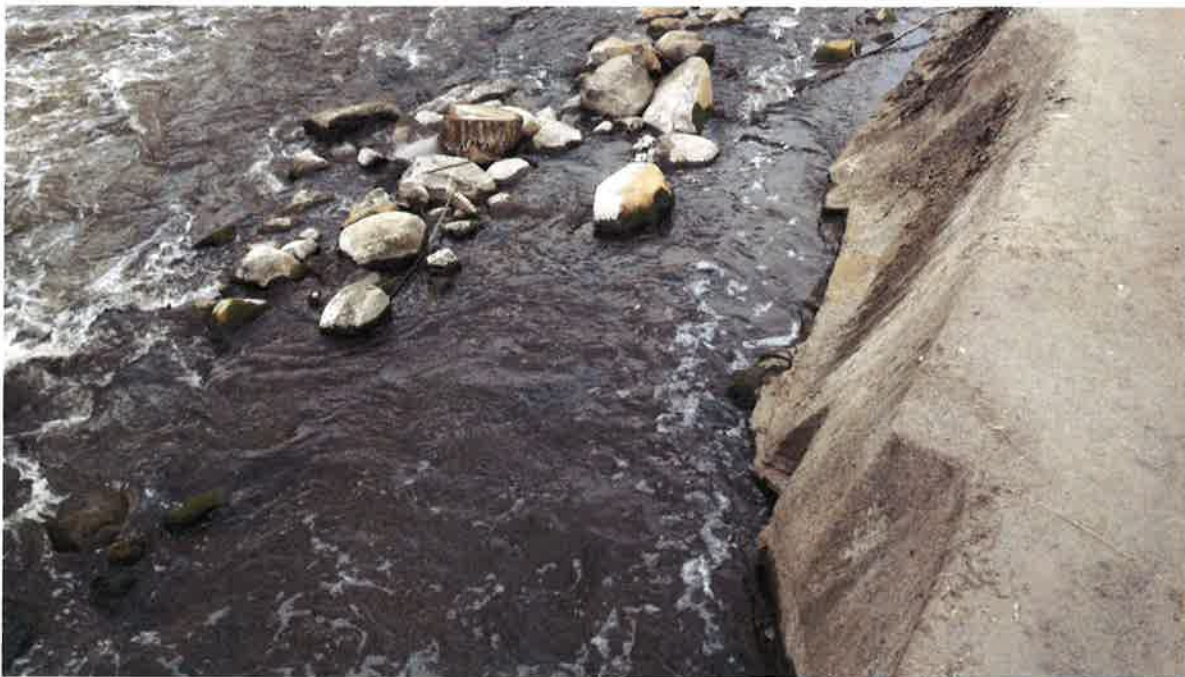
Burlington Echo Lake Dam
Auxiliary spillway near vertical section

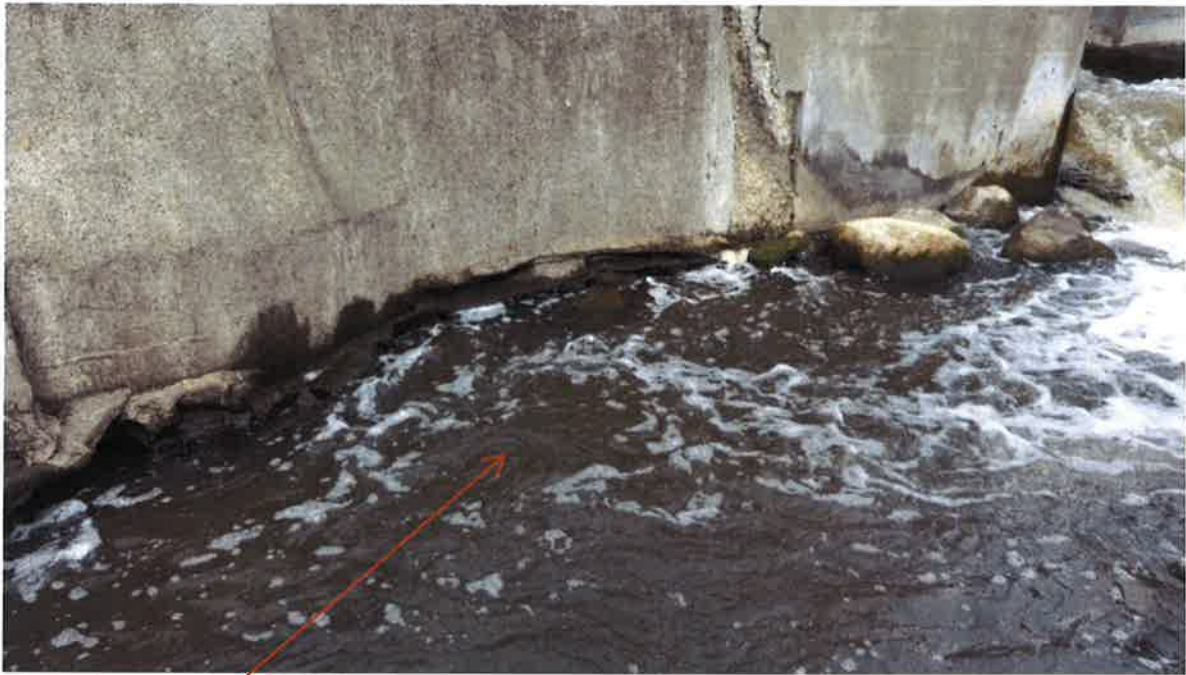
The Auxiliary spillway consists of two different shaped sections. The far left end the spillway drops off vertically without an ogee shape. In this area the amount of vertical scour was up to four feet deep (see photo). The majority of the spillway has an ogee shape and in these areas riprap is still at the toe of the spillway base.

Scour depth of 4'

Burlington Echo Lake Dam
Auxiliary spillway near vertical section

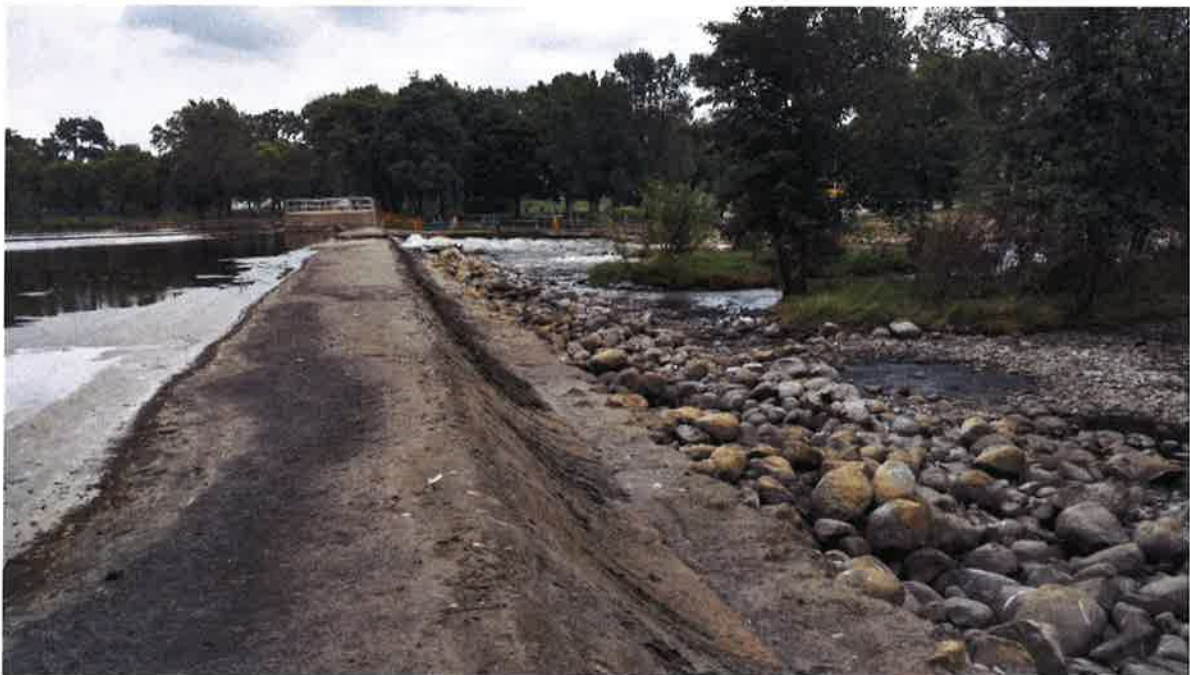
Burlington Echo Lake Dam
Auxiliary spillway from viewed from right

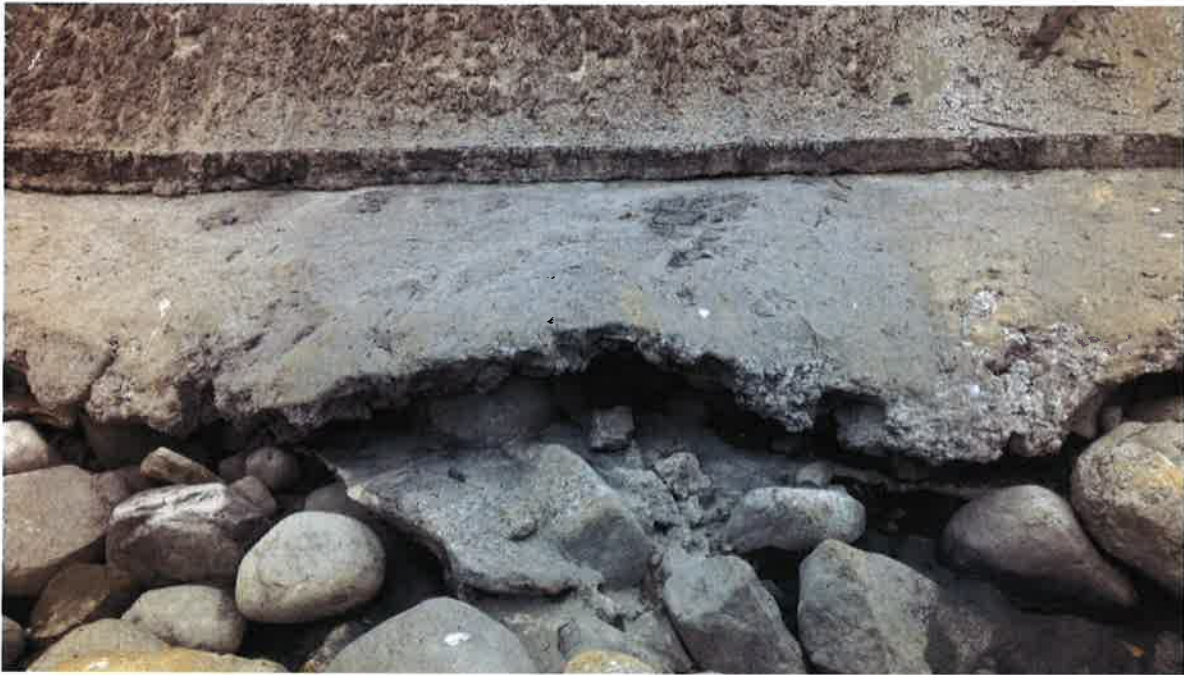
We did walk the spillway and probed with the survey rod and noted several areas where the spillway is undermined up to 2 feet, with most areas being about 12 inches.

Burlington Echo Lake Dam
Typical undermining of 1 foot under spillway

It appears that overall the Echo Lake dam withstood the flood with minimal damage. The displaced riprap and sidewalk scour can be repaired and are typical of routine maintenance required post flood. The undermining noted is likely not a result of this recent flood, but more a long term chronic problem. If the spillway continues to undermine the stability could be compromised and the City should consider grouting the downstream side of the spillway to halt this undermining.

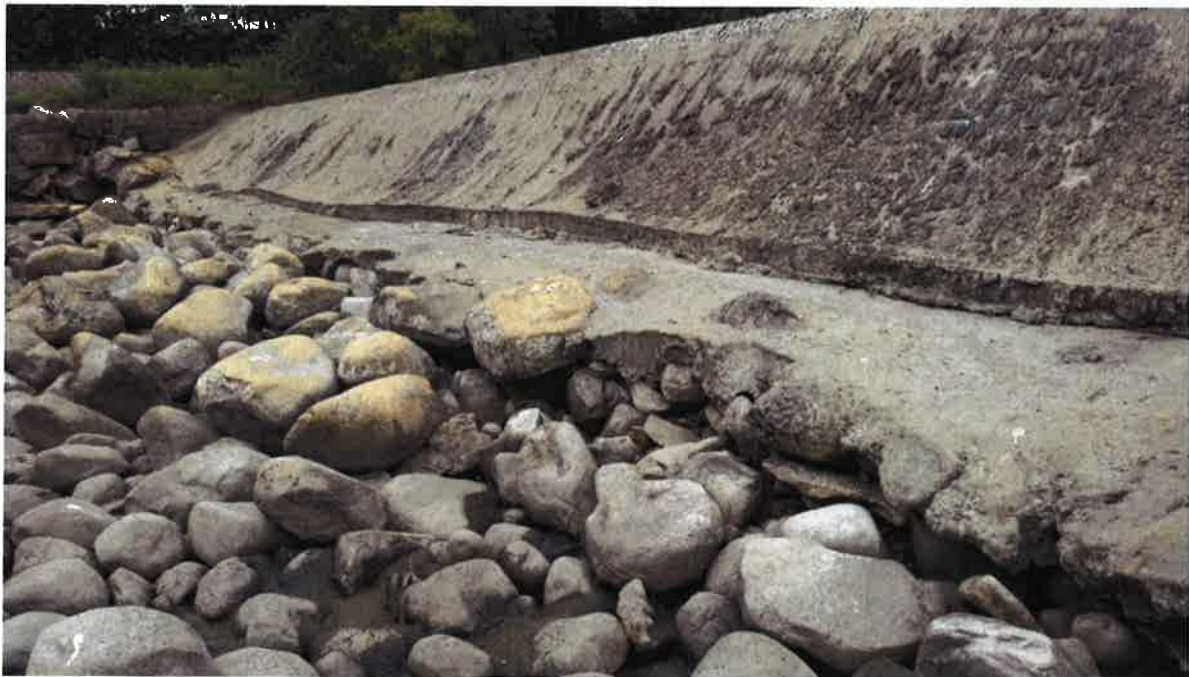
Burlington Echo Lake Dam
Spillway undermining

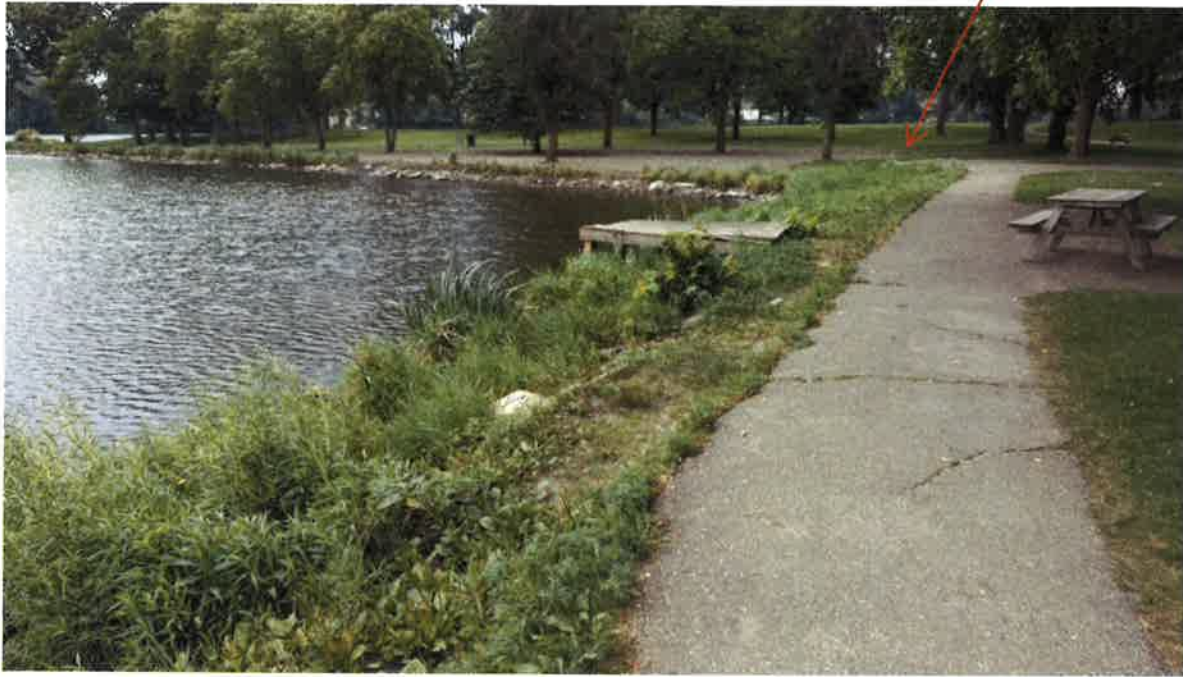
The embankment section of the dam did not over top during the July flood. Sediment stains are present, as noted in attached photographs, which show the highwater mark on the embankment. The embankment is in good condition with no observed seepage, rodents, trees, brush or erosion concerns.

Burlington Echo Lake Dam
Embankment
